RE: Site Closure Request
Hertz Rent A Car
5300 Rent A Car Road
Las Vegas, Nevada
Facility ID #8-000224
Petroleum Fund Case # 92-079

Ogden on behalf of Hertz is pleased to provide the DEP-DWR with this letter report, which summarizes the site closure and restoration activities performed during the week of February 28, 2000 at subject site. The field activities were performed in accordance with the State of Nevada Petroleum Fund CEM Cost Guidelines, dated August 13, 1996 and the Petroleum Fund Not to Exceed Proposal approved on February 14, 2000 by Mr. Todd Croft, Environmental Scientist III Division of Environmental Protection, Bureau of Corrective Actions, Remediation and LUST Branch.

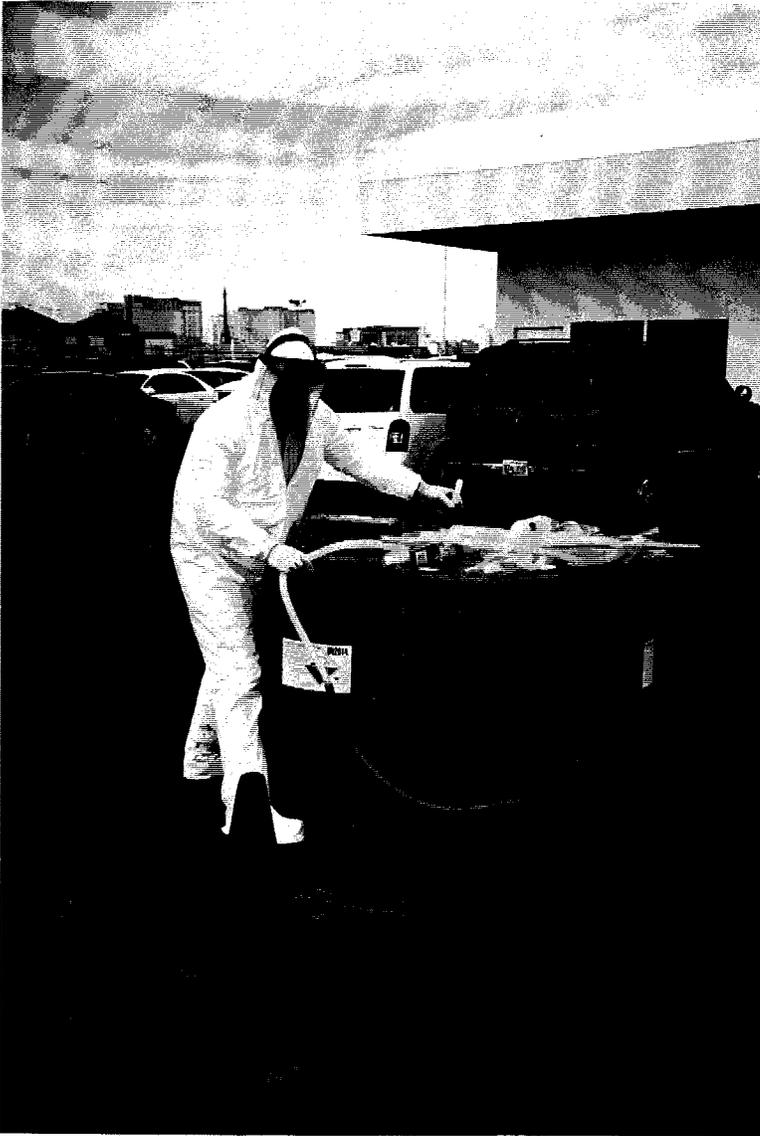
Photograph 1 – 2% Hydrogen peroxide being injected at monitoring well MW-8
February 29, 2000.

- Ogden on behalf of Hertz obtained authorization from Ms. Valarie King, Division Environmental Protection, Bureau of Water Pollution Control, Underground Injection Control Program for the one time injection of total of 2500 gallons of 2 % solution of hydrogen peroxide into select on and off site monitoring wells.
- On February 28 and 29, 2000, Ogden injected a 2 % solution of hydrogen peroxide into on and off site monitoring wells. The 2 % solution of hydrogen peroxide was injected to

increase O₂ concentrations, enhance the degradation process, and accelerate natural attenuation. The injection rates were as follows:

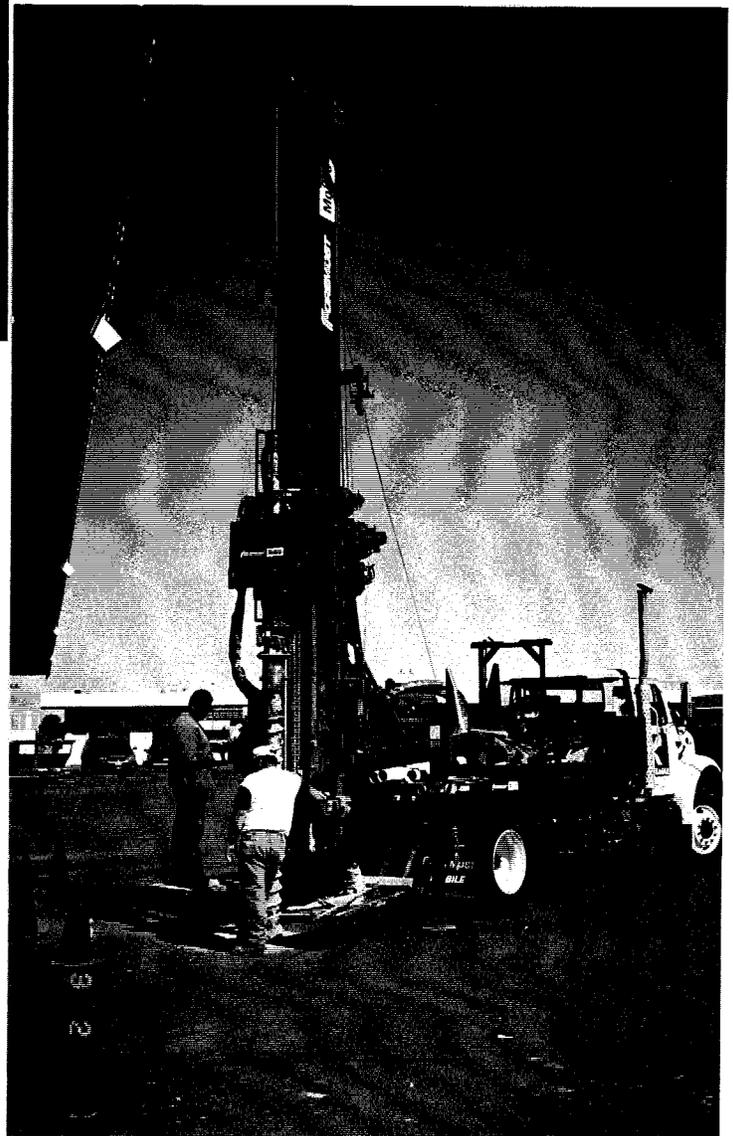
Photograph 2 – Monitoring well MW-5 being plugged and abandoned on March 2, 2000.

- Prior to well abandonment activities, Ogden capped all air and/or liquid transfer lines located in recovery/air sparge and/or vacuum extraction wells vaults prior to the wells vault being filled and sealed with a non-shrink grout cement.
- On March 2, and 3, 2000, Ogden supervised Eagle Drilling Services LLC, of Las Vegas Nevada, in the plugging and abandoning on and off site monitoring wells MW-1 through MW-17, air sparge wells AS-1 through AS-4, and soil vacuum extraction well VE-1. A copy of the State of Nevada, Division of Water Resources Well Driller's Report, certifying the wells were plugged and abandoned in accordance with Nevada Administrative Code 534.420, is included as Attachment A of this correspondence.

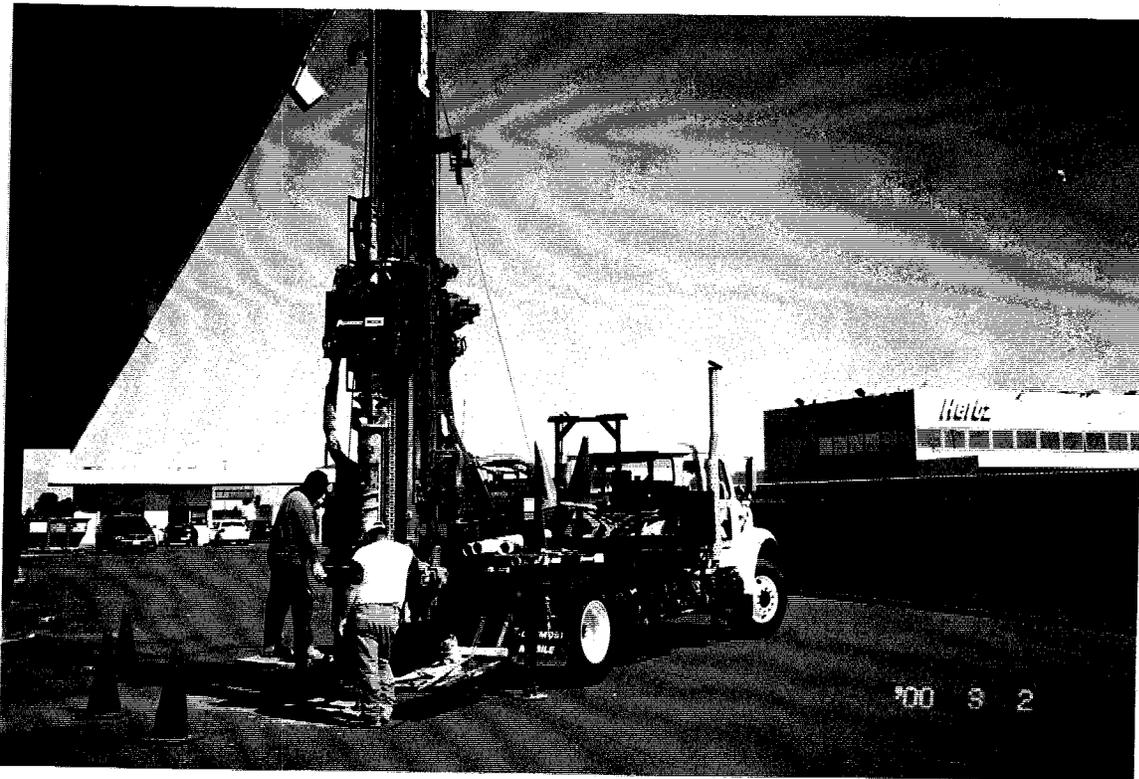
Photograph No. 3. - Monitoring well MW-2 being plugged and abandoned on March 2, 2000.

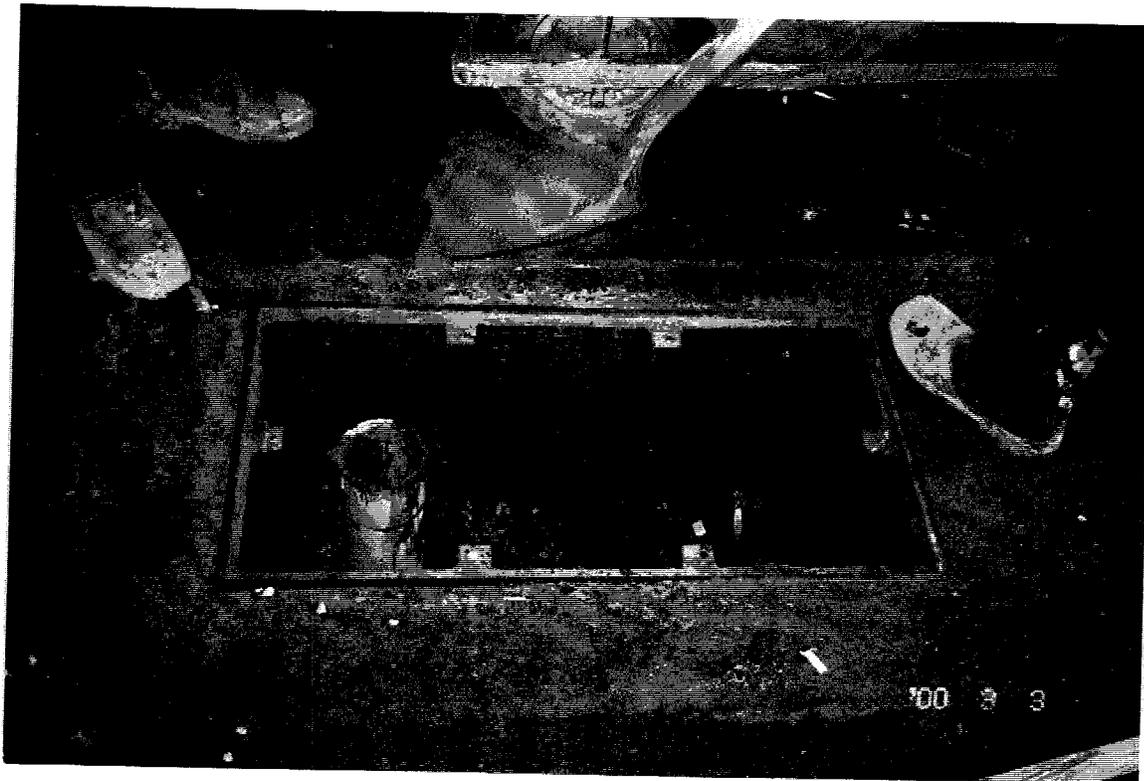
Photograph No. 4. - Well vault grouting activities on March 3, 2000.

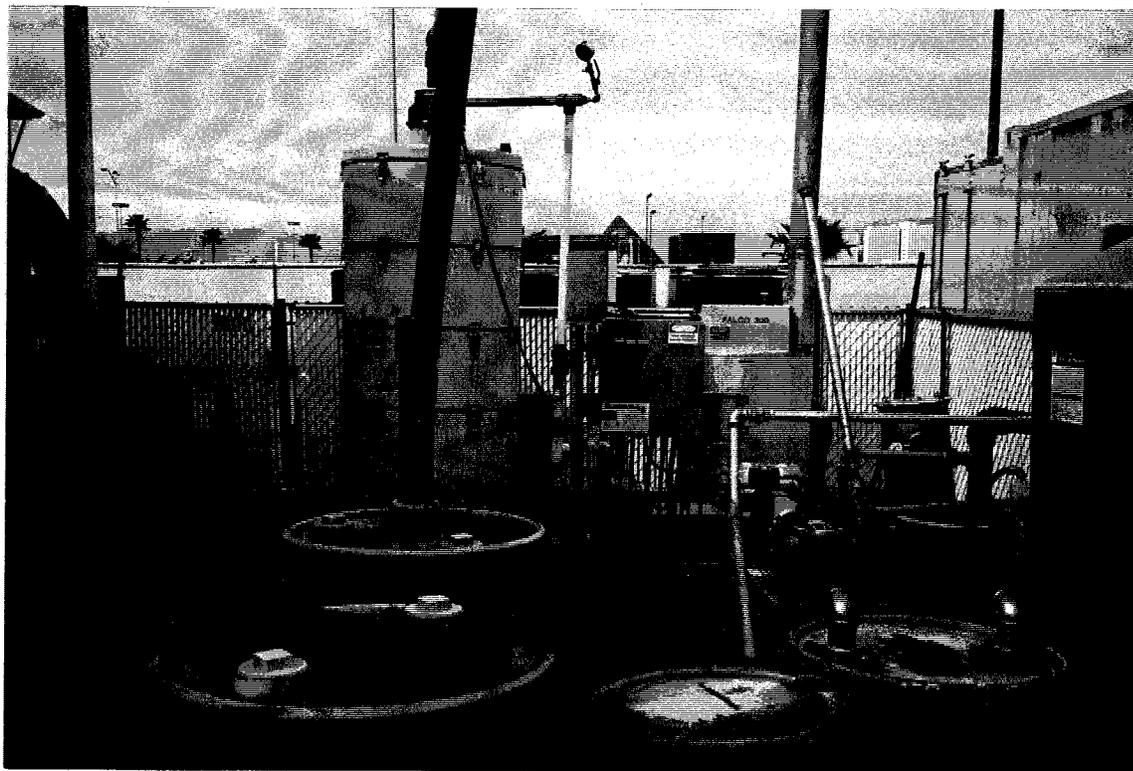
Photograph No. 5 -Remedial equipment components within system enclosure on February 29, 2000 prior to system decommissioning.

- Ogden coordinated the decommissioning/removal of the onsite remedial system. The remedial system components were decommissioned and removed from the site.

- Ogden drained the above ground equalization tanks, the knockout pot, the air stripper, the liquid phase carbon canister, and above ground transfer lines of any liquid. All surface piping was removed and disposed.

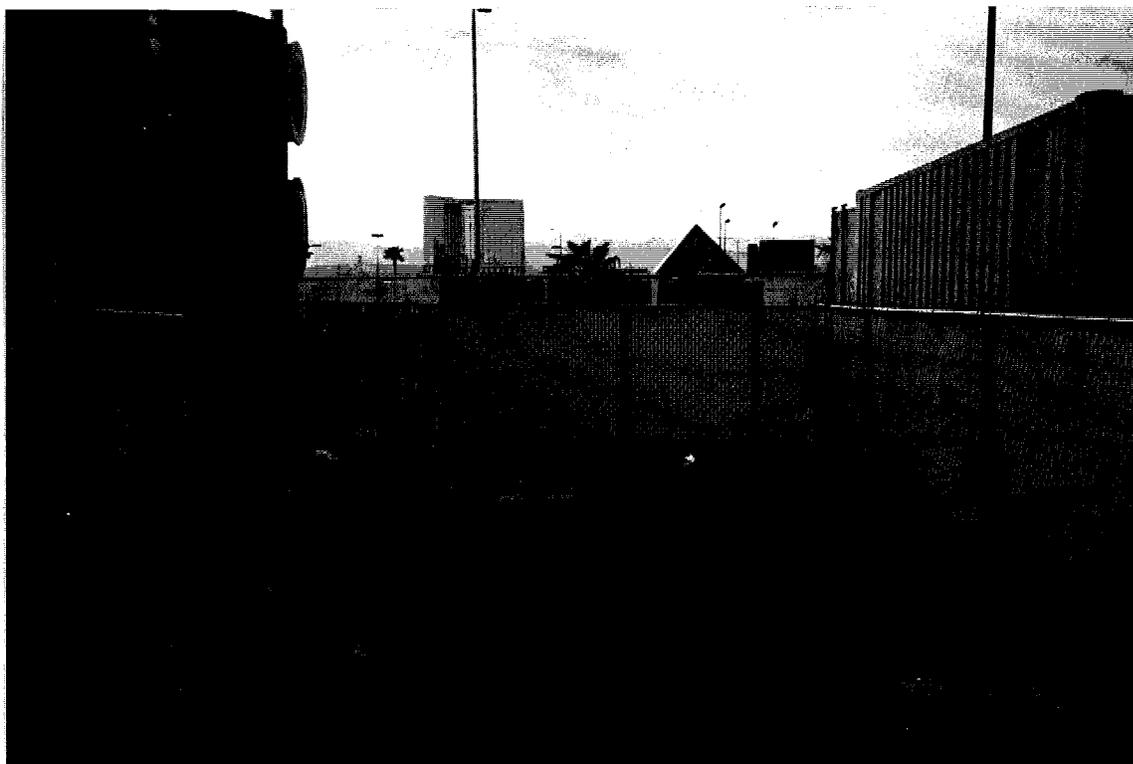
Photograph No. 6 - System enclosure on March 3, 2000 following remedial equipment decommissioning and removal.
